**NUMBER: FSB 97-3
DECEMBER 1997****ROUTINE**

MDS 9810 SOFTWARE RELEASE V2.0

For all MDS 9810 radio transceivers manufactured before December 5, 1997.

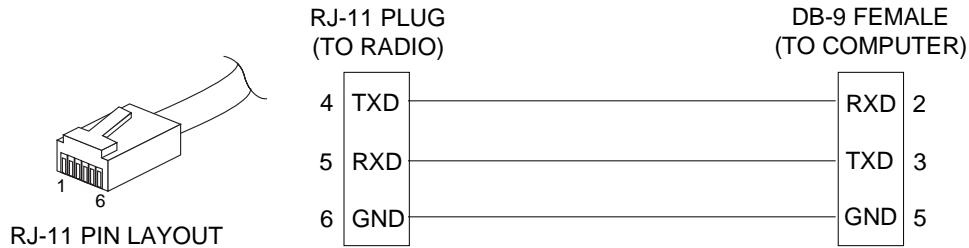
Figure 1. RJ-11 to DB-9 Adapter Cable (for PC Diagnostics & Control)

To connect a PC to the radio's **DIAGNOSTICS** port, an RJ-11 to DB-9 adapter cable (MDS P/N 03-3246A01) is required. If desired, this cable may be constructed using the information shown in Figure 1.

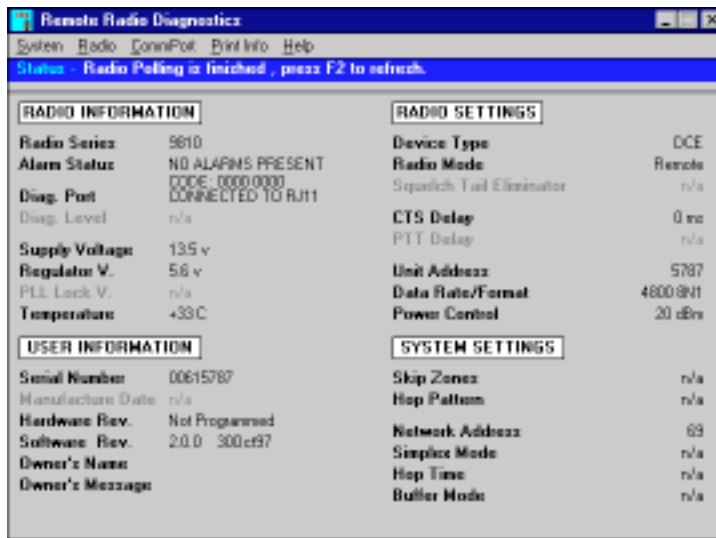
Figure 2. Data Screen from the *Radio Diagnostics* Software

The MDS 9810's current software revision can be determined through the use of the MDS hand-held terminal (HHT) connected to the radio. Use the **SREV** command to ask the radio to display the currently installed software information. Or use the *REMOTE Radio Diagnostics* software and read the Software Rev. from the data screen as shown below.
