## Upgrading SD Radio Firmware

## Firmware Upgrade via Serial Port (COM1)

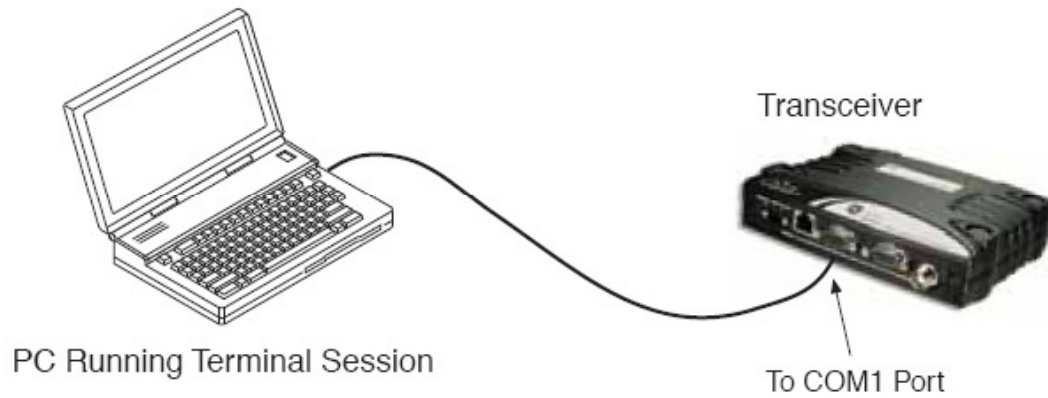
Connect the transceiver for firmware upgrade as shown below.

**Figure 1. PC Connection to Transceiver**

1. Connect a straight-through DB-9 cable from the PC to the transceiver's COM1 Port.
2. Launch a Terminal Program such as HyperTerminal with the following communication parameters: Baud 115200, 8 data bits, no parity, one stop bit (8N1), XON/XOFF flow control, VT100 emulation.
3. Remaining steps will vary based on the SD model purchased and the radio's operating mode.
  - For Models "ES" & "SS" the radio is typically configured through the menu interface.
  - For Model "MS" the radio must be configured through the SD command line.
  - Examples of each are shown below.

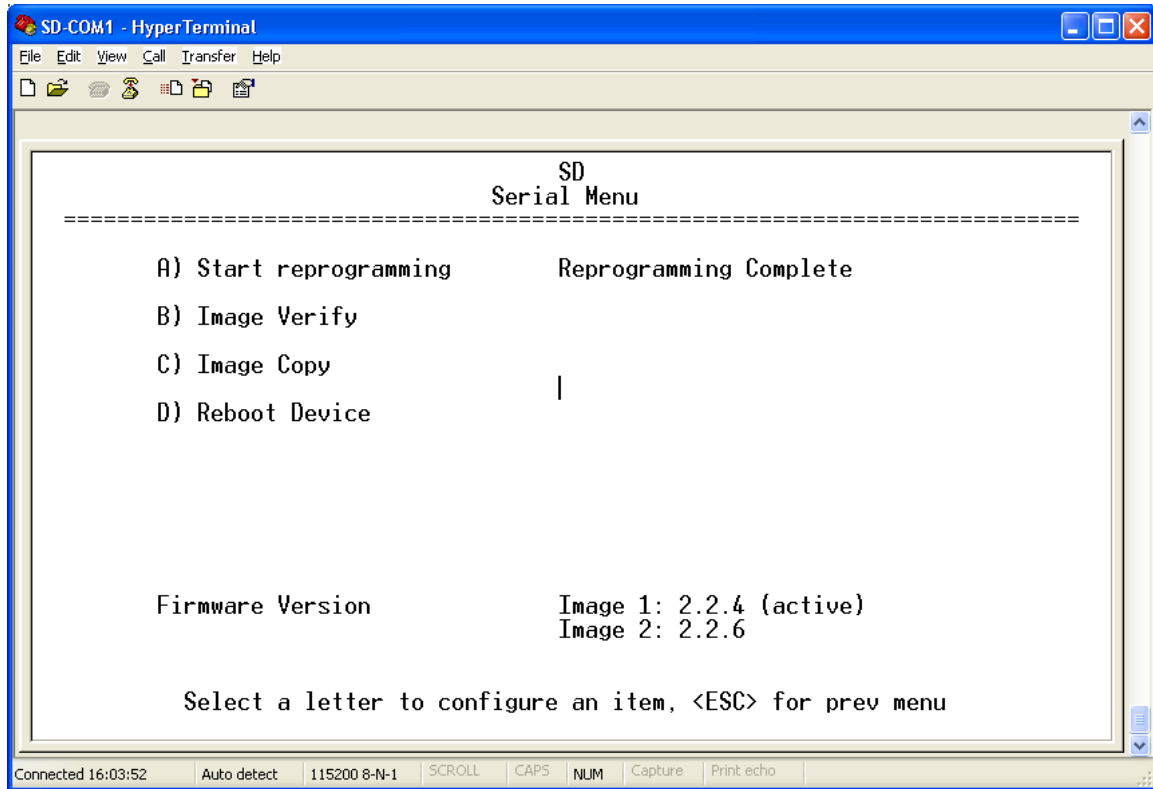
6. As soon as reprogramming is complete, the screen shown in Figure 5 is displayed.

**Figure 5. Reprogram Menu**

7. To verify the image downloaded into flash use the **Image Verify** option. Make sure to select the *inactive* image when the choice is presented.
8. After verification is successfully completed, reboot to the inactive image using the **Reboot Device** option.
9. After reboot, verify the radio is running the new application by logging in and viewing the Firmware Version shown on the Starting Information Screen.
